**COLEMAN DAM**

**NDI ID NO. PA-00191**

**PHASE I INSPECTION REPORT  
NATIONAL DAM INSPECTION PROGRAM**

Prepared by  
Geo-Technical Services, Inc.  
CONSULTING ENGINEERS & GEOLOGISTS  
851 S. 19th Street  
Harrisburg, Pennsylvania 17104

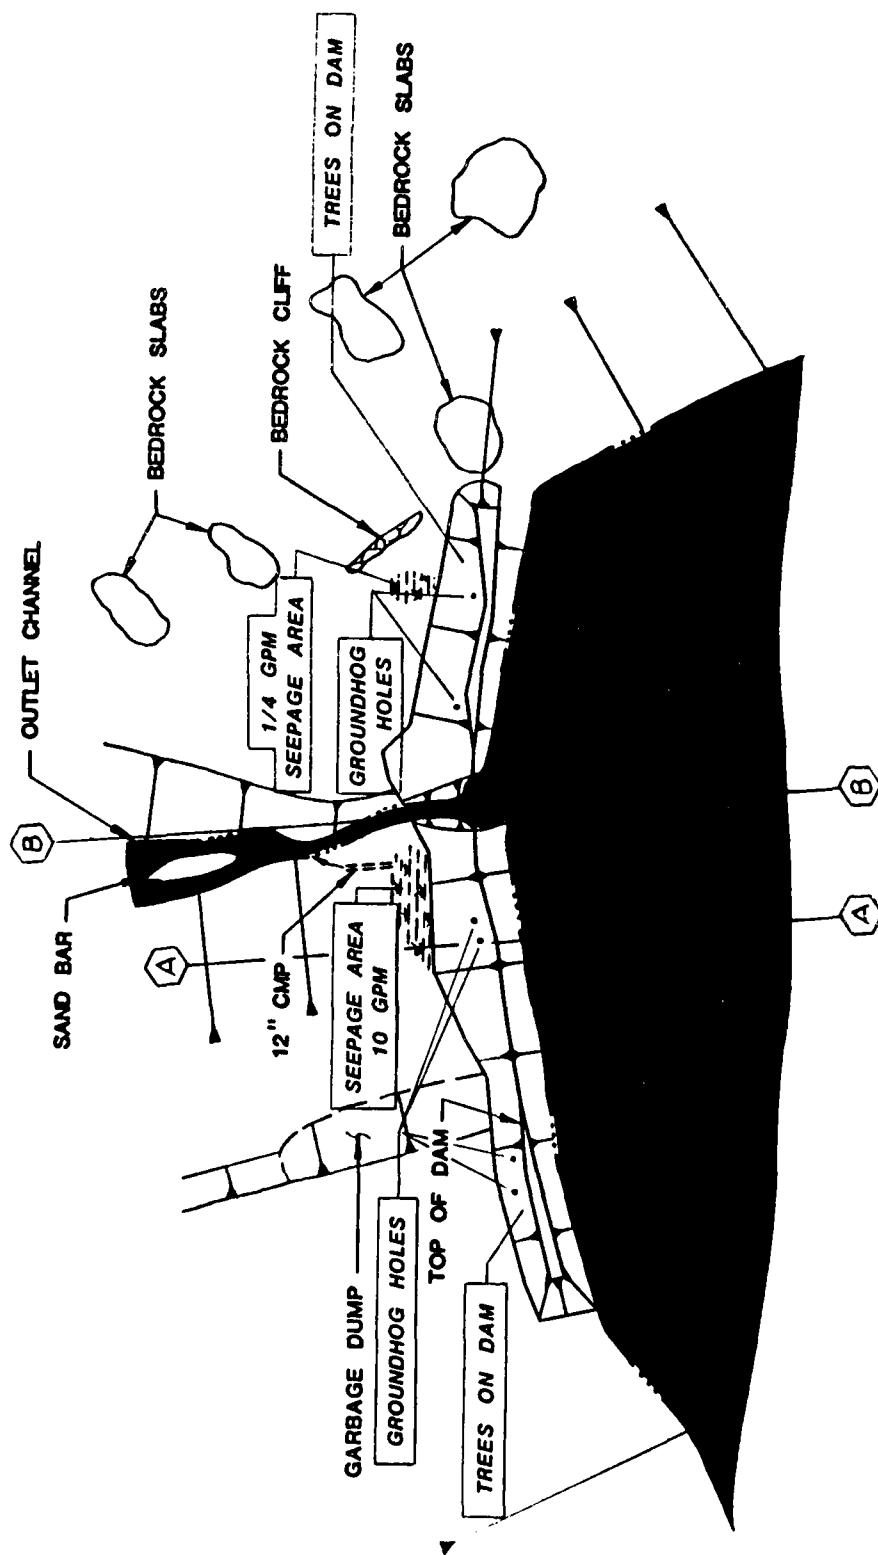
# COLEMAN DAM GENERAL PLAN - FIELD INSPECTION NOTES

a. General. The overall appearance of the dam is very poor. Location of observed deficiencies are shown on the General Plan presented in Exhibit A-1, Appendix A. The profile and typical sections of the dam are presented in Exhibits A-2 and A-3 and are based on field survey made on the day of the inspection. The survey datum for this inspection is elevation 1572 feet above mean sea level for the normal water surface of the Lake (see Exhibit E-1). On the inspection date (3/02/81), the lake level was approximately at elevation 1572, which is also the low point near the middle of the dam crest (see Exhibit A-2). Deficiencies observed during the field inspection are described below, and are illustrated in Exhibit A-1, Appendix A. Visible features are depicted in photographs, presented in Appendix C.

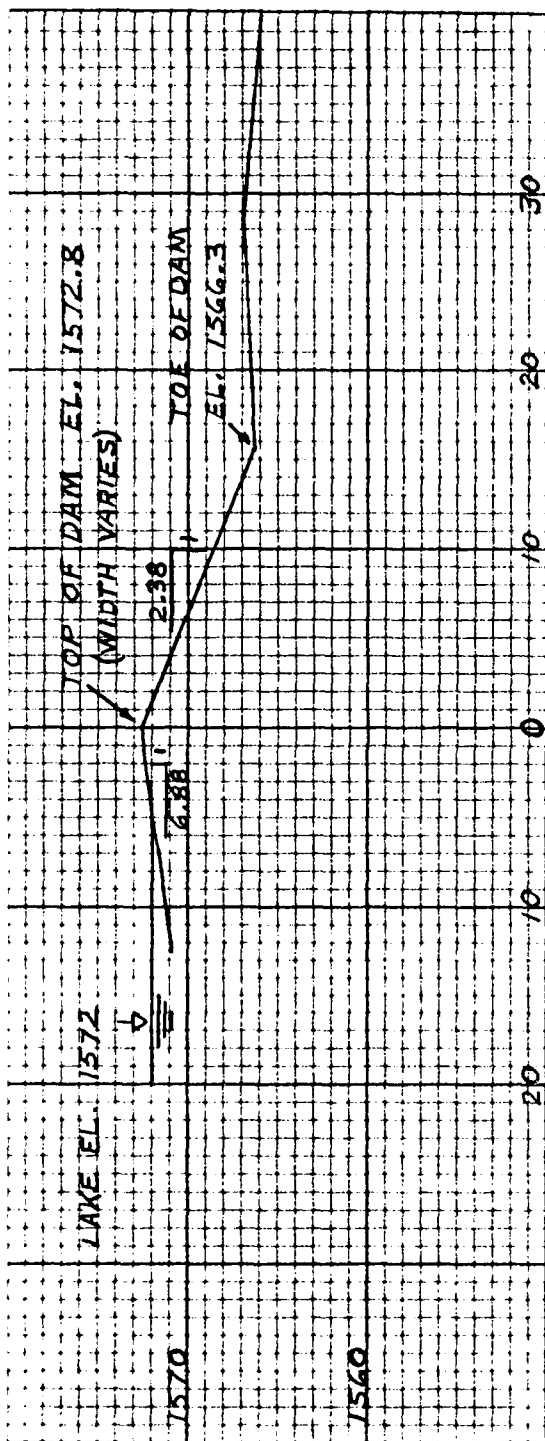
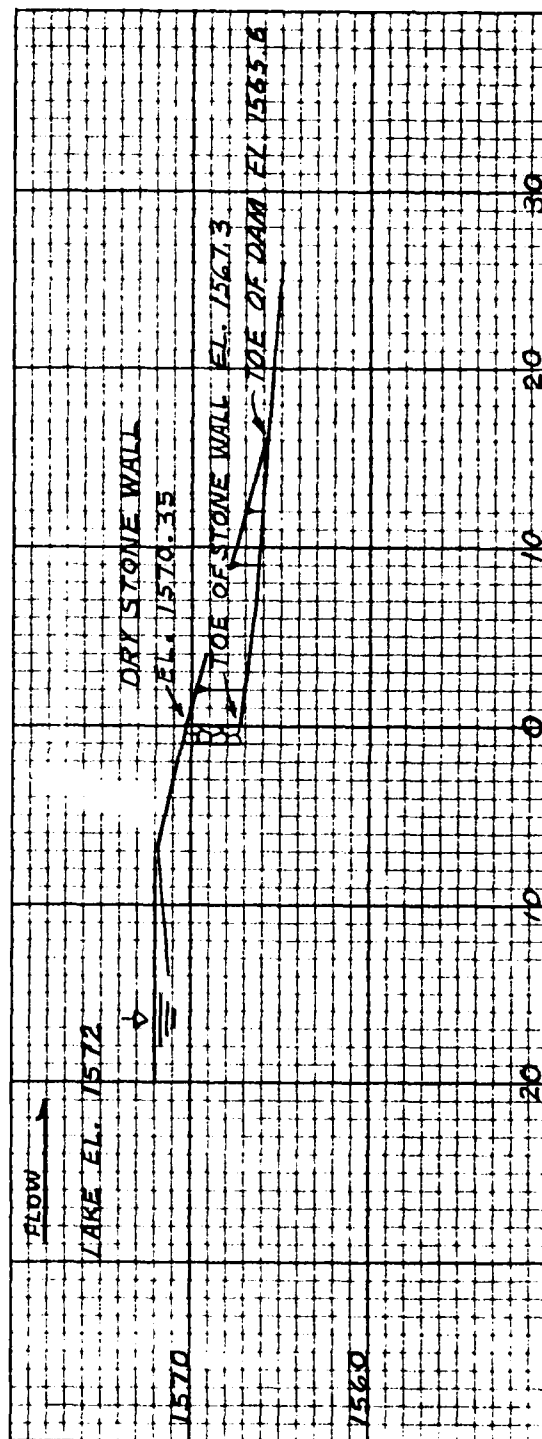
TYPICAL DAM SECTIONS

a. Dam. Irregularities in top of dam elevation are presented in Exhibit A-2. The lowest crest elevation 1572 is located upstream of the exposed dry stone wall (see Section B, Exhibit A-3). On the day of the inspection the reservoir level was approximately  $\frac{1}{4}$ -inch above the lowest dam crest elevation, resulting in overtopping of the dam. Water overflowing the crest was observed to flow over and through the exposed downstream stone wall into the stream channel.
